N55: Which Harness Do I Need?

Early N55 models have a different HPFP electrical connection than the later cars. Technically the cutoff is a build date of **12/2013** and later for the **New Style Connector** and anything before 12/2013 for the **Old Style Connector**.

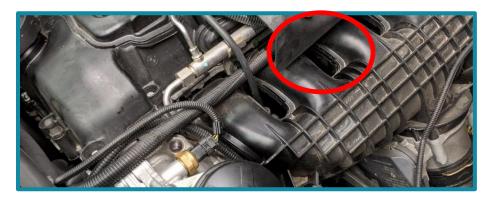
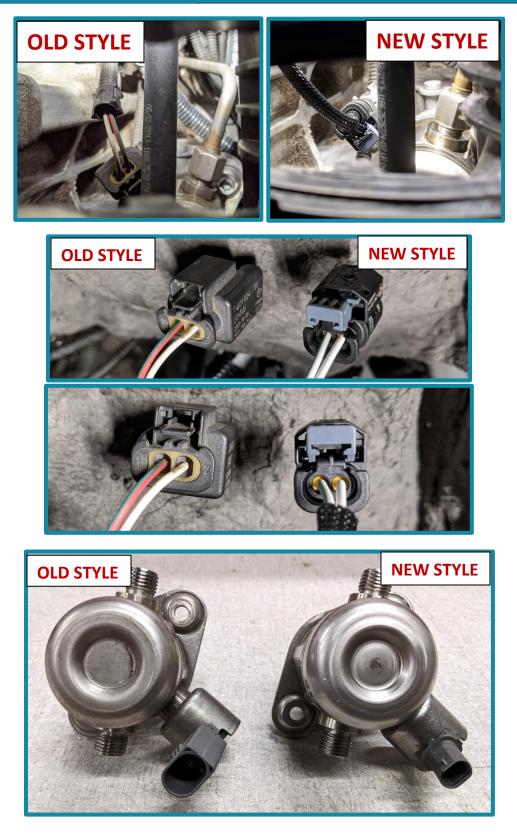
For most vehicles, you can simply remove the airbox and check the connector style with a flash light. The HPFP is located below the intake manifold and can be viewed between the intake runners:

For the VIN above, the car actually still has an OLD style harness! It's hit or miss between 12/2013 and 6/2014.
